Certified Arborist's Pre-Construction Tree Inventory & Report

September 07, 2016

– Commercial Site–

3375 Scott Boulevard

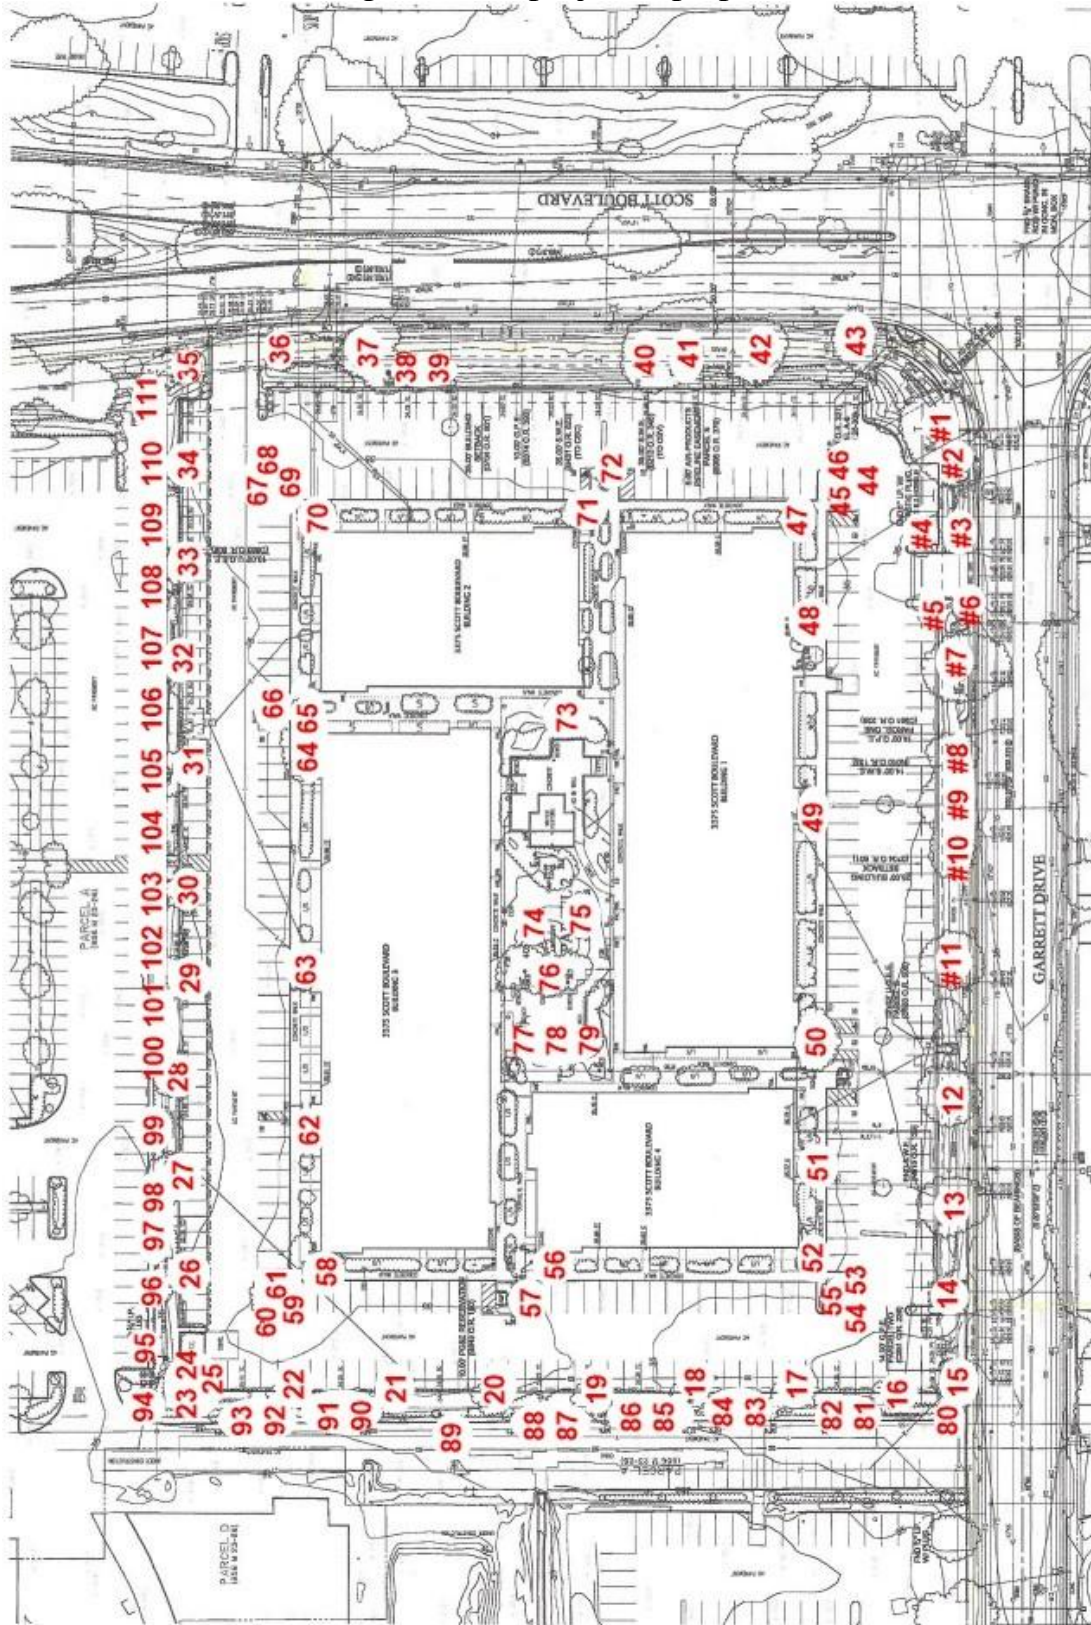
4.2 Site Plan (Existing Trees on project topo plan)

**Tree Numbers Added by Ray Morneau, Arborist, in approximate locations to accompany
August 2016 Pre-Construction Tree Inventory Report ... on topo provided by this project.**
